PAE Living Building Team Perseveres Through Pandemic and Unwelcome Outside Forces

June 23, 2021

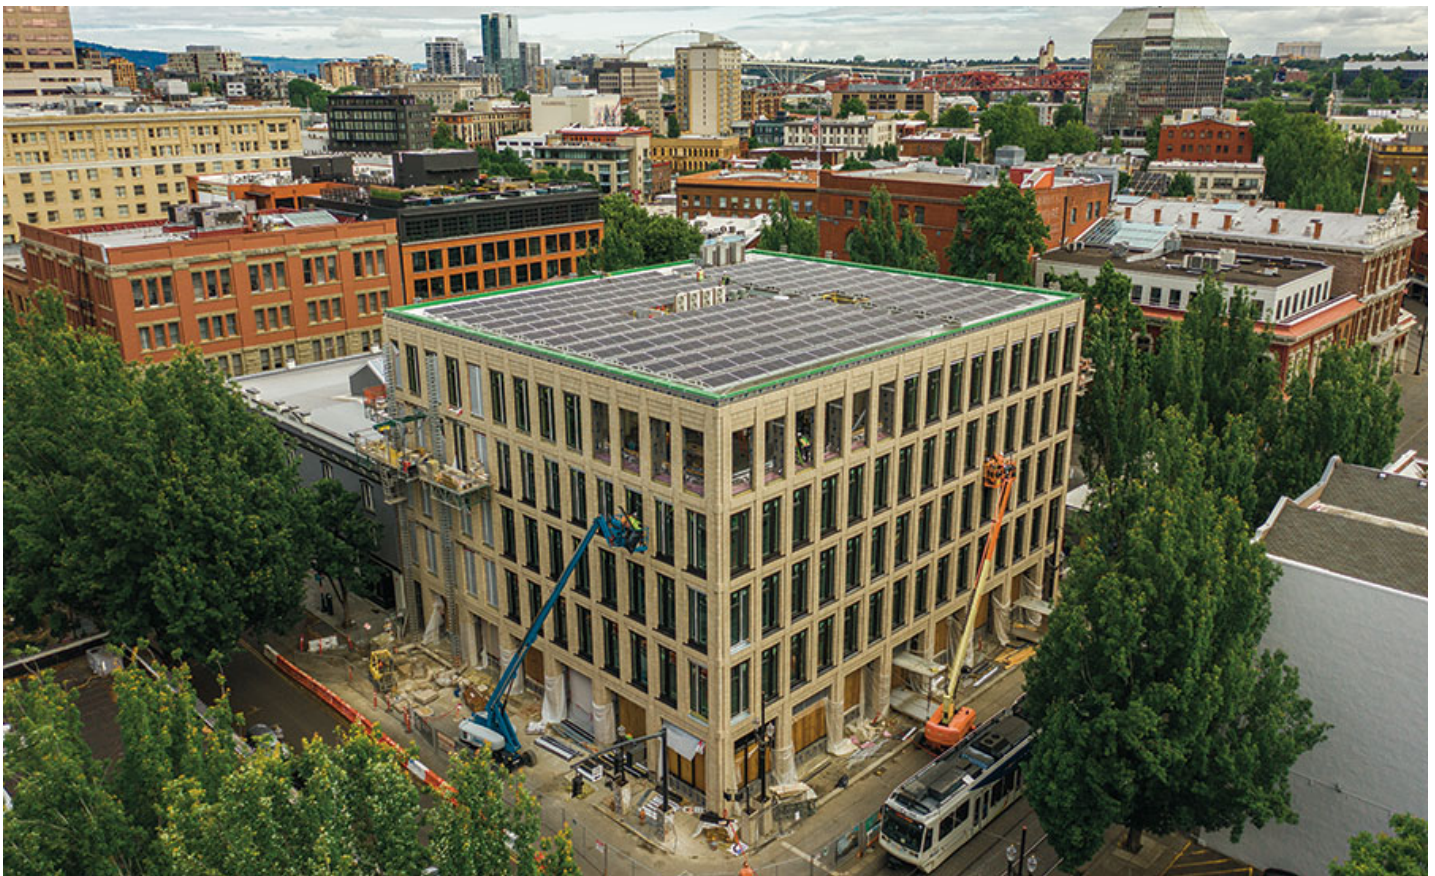
PAE Living Building nearing completion in Portland, Ore., has a vintage veneer to respect its location in the Skidmore/Old Town historic district but it contains cutting-edge sustainable and resilient building systems.

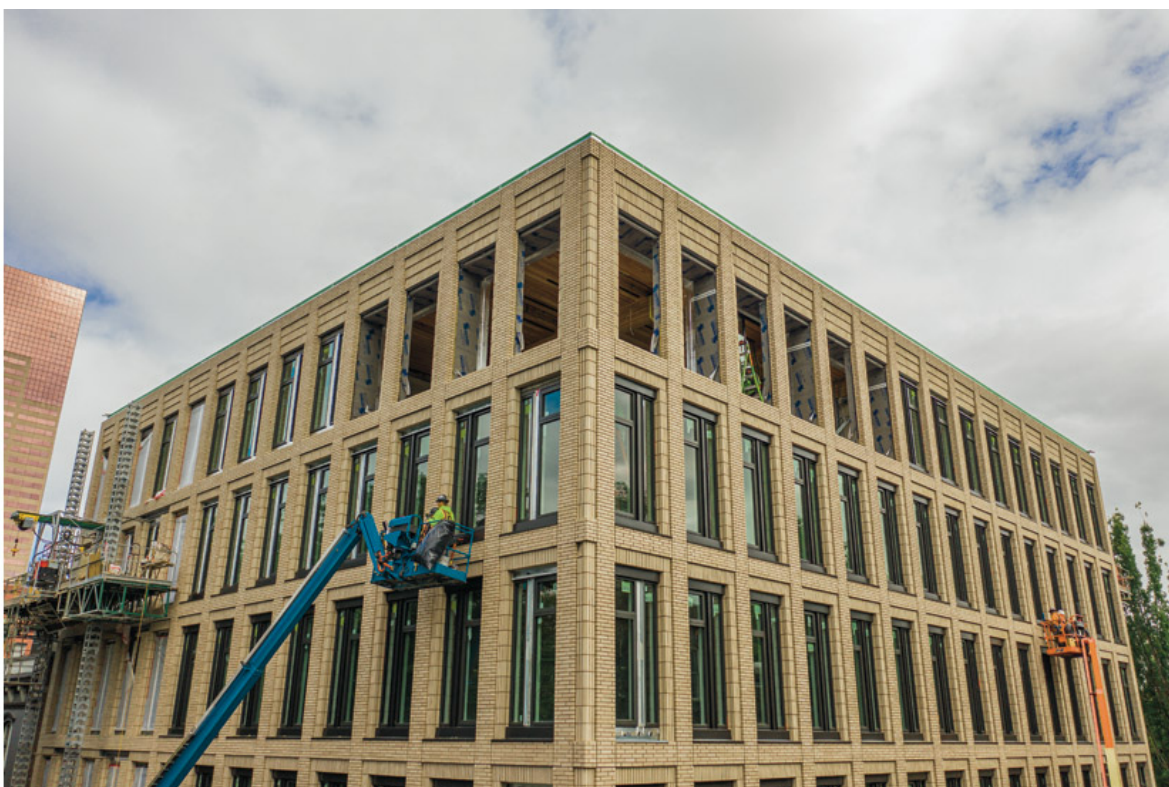
Brick exterior is inspired by the location in the Skidmore/Old Town national historic district.

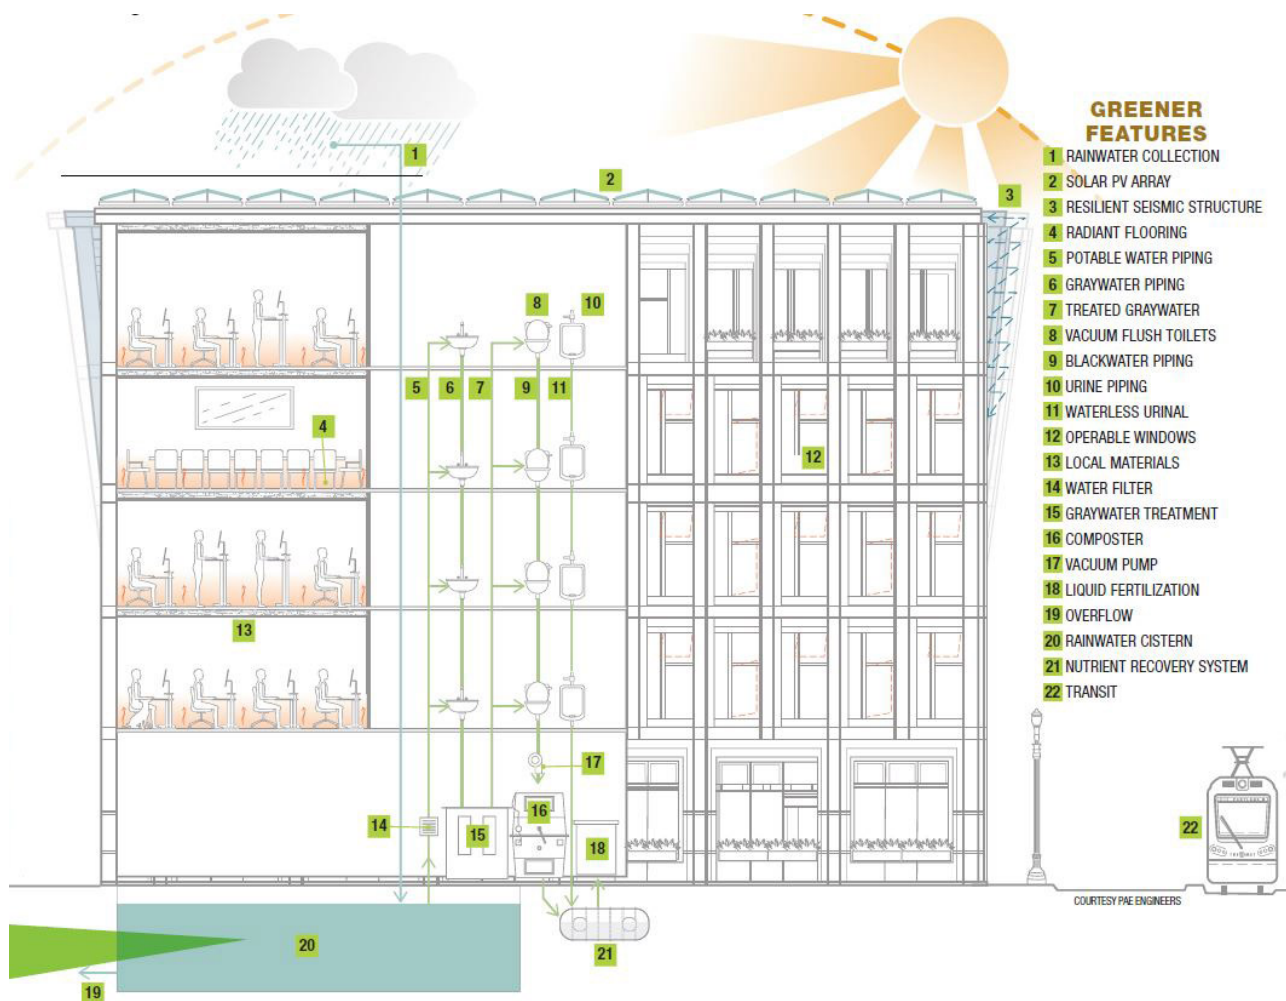
The 58,000-sq-ft PAE Living Building, more than 85% complete, is breaking several Living Building Challenge records. It is the first privately developed Living office building, the only seismically resilient Living Building and the only commercial building that will turn urine into fertilizer.

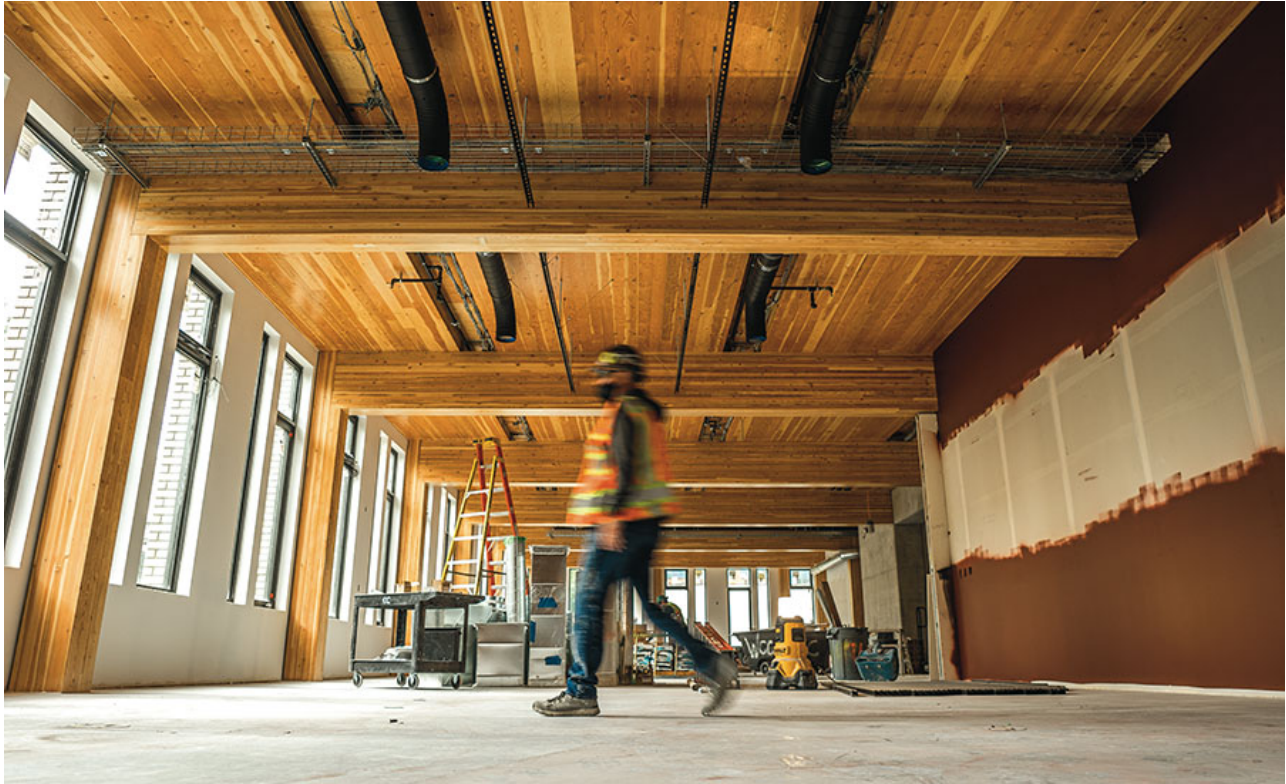
The underside of the CLT panels, which contain mechanical chases, are architecturally expressed.

One hiccup cleared early on relates to the CLT layout, which called for 9-ft-wide x 30-ft-long ceiling panels, separated by a horizontal mechanical chase—topped with concrete to create the floor diaphragm. Almost all CLT fabricators, including Structurlam, produce either 8-ft-wide or 10-ft-wide panels. Cutting wider panels 1 ft along their 30-ft length would have resulted in too much wasted material, says Alese Ashuckian, Structurlam’s mass timber specialist. To solve the problem, Structurlam retooled its press by inserting a temporary jig to produce the 9-ft panels. Structurlam doesn’t retool its press often, says Ashuckian.

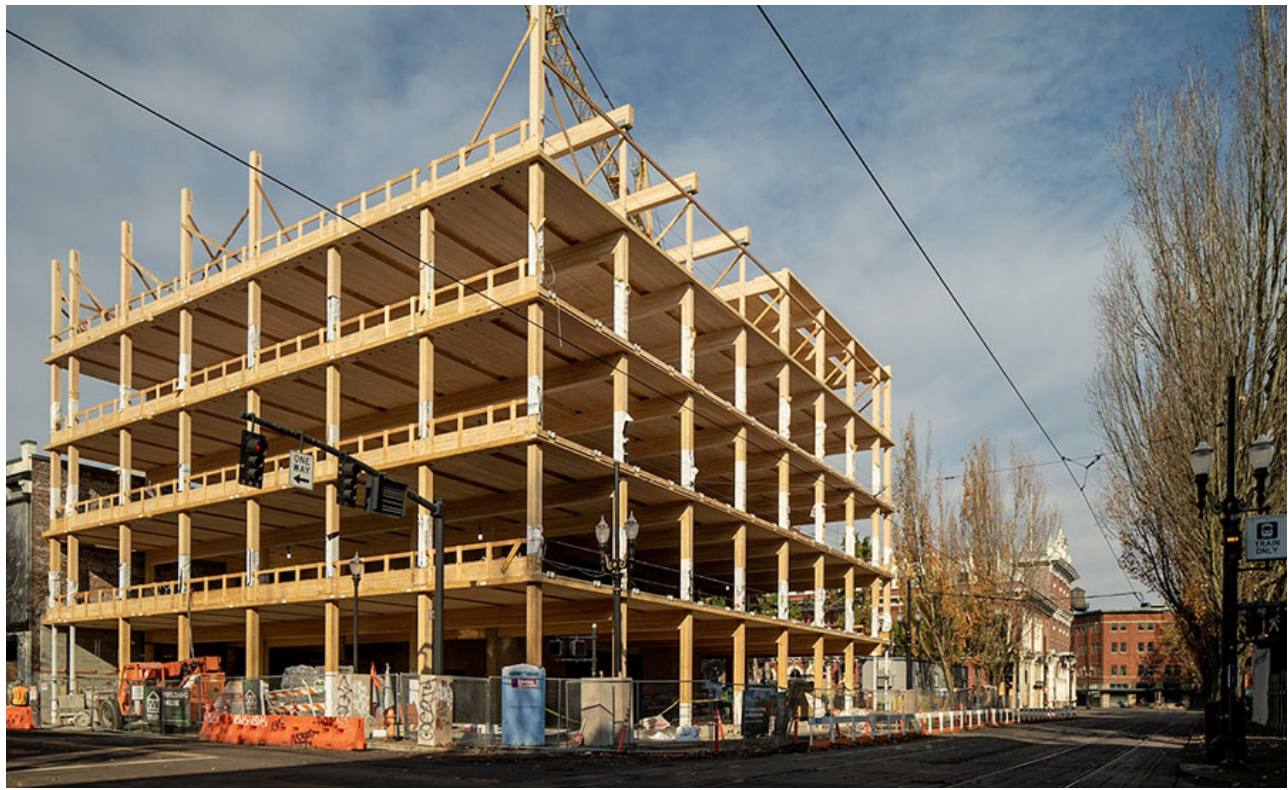
The installation of the mass timber frame was one of the most challenging aspects of the project, especially because a delayed start pushed the work into the wet season.

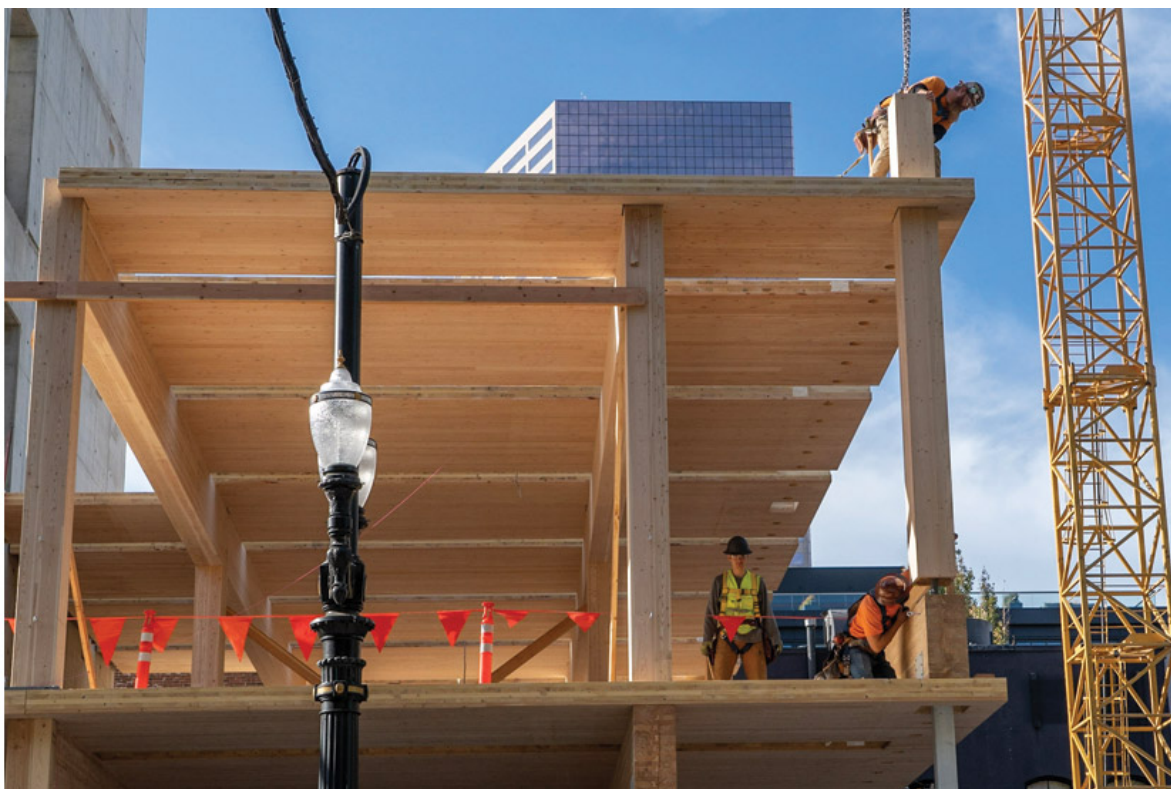
Plywood was nailed over voids between CLT panels, which along with straps, created temporary floor diaphragms so that the timber installation could proceed without the concrete topping slabs.

Sloop credits the expertise of Carpentry Plus as key to the success of the timber installation. For example, for stability reasons, the frame could not go higher than level three without topping slabs coming up behind it to complete the floor diaphragms.

To avoid waiting for the slab, Carpentry Plus crews nailed plywood over the spaces between panels and strapped panels together to create a temporary diaphragm. Crews topped out the frame in five instead of 10 weeks.

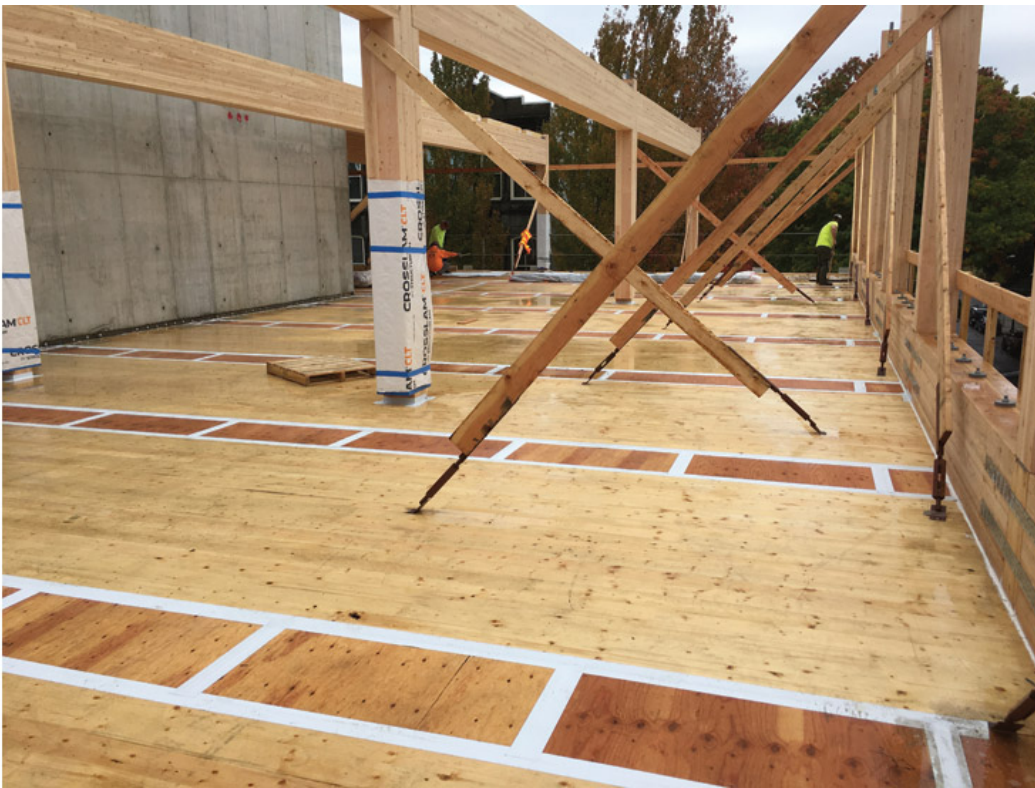
Taped seams, edges keep rain from dripping down and staining the timber below.

The timber moisture mitigation plan included taping and caulking panel seams and edges to prevent staining of the architecturally expressed beams and columns below the panels. Whenever it rained, a crew of four to six with squeegee brooms would remove water from the decks to prevent puddling.

Blowers circulated air but heating was not an option because drying out the panels too quickly could cause cracking, twisting and possibly delamination, says WCC's Sloop. Weekly moisture tests at all floors ensured the timber was drying at the proper rate.
